Custom Dynamics® Tech Bulletin
Water Intrusion HD Auxiliary Lighting Kits
(68000043, 8000042, 67800366A, 69228-04, 69230-04, 69818-06)

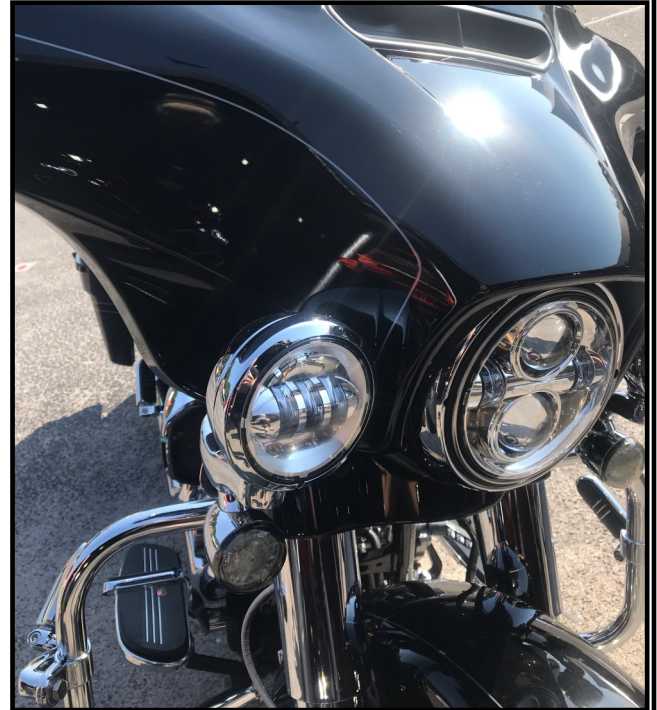
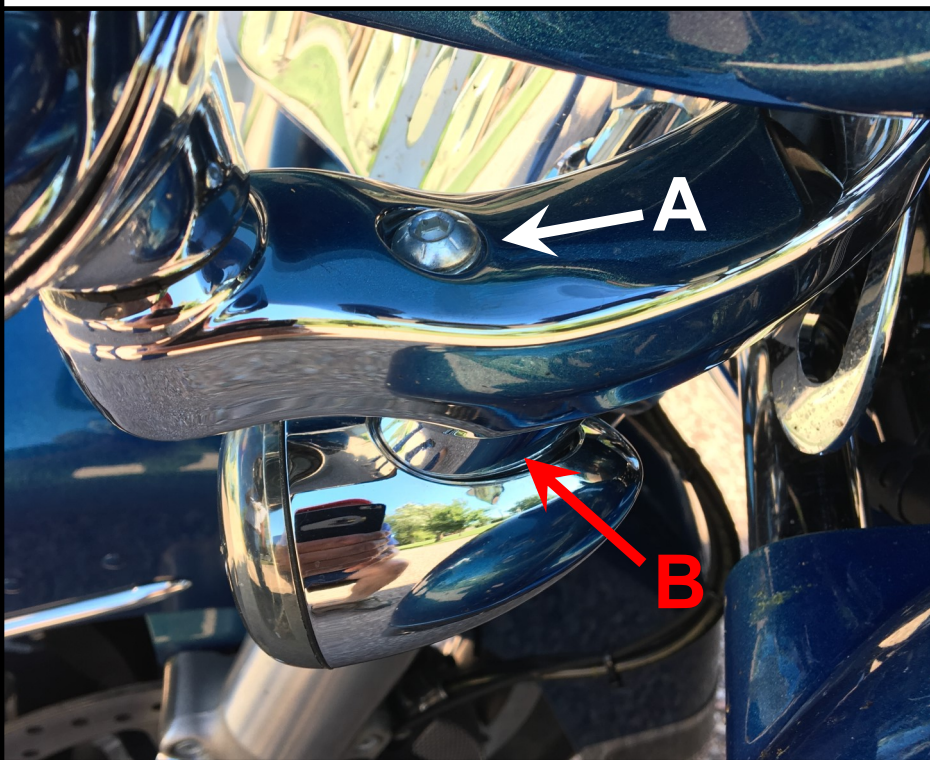
We have seen several touring models where the turn signals mount under the passing lamp bracket, have excessive water damage inside the turn signal housing. This is not from adding aftermarket lighting as it is happening with bikes that have OEM turn signal lenses and bulbs installed.

Water is entering the turn signal housing from one of two places. Water can enter through the Allen head mounting bolt (See Arrow A). Water can also enter through the top and bottom of the turn signal mount (See Arrow B).

Preventive measures need to be taken to seal the areas to prevent water from entering into the turn signal housing and causing excessive water damage to the inside of the turn signal housing.

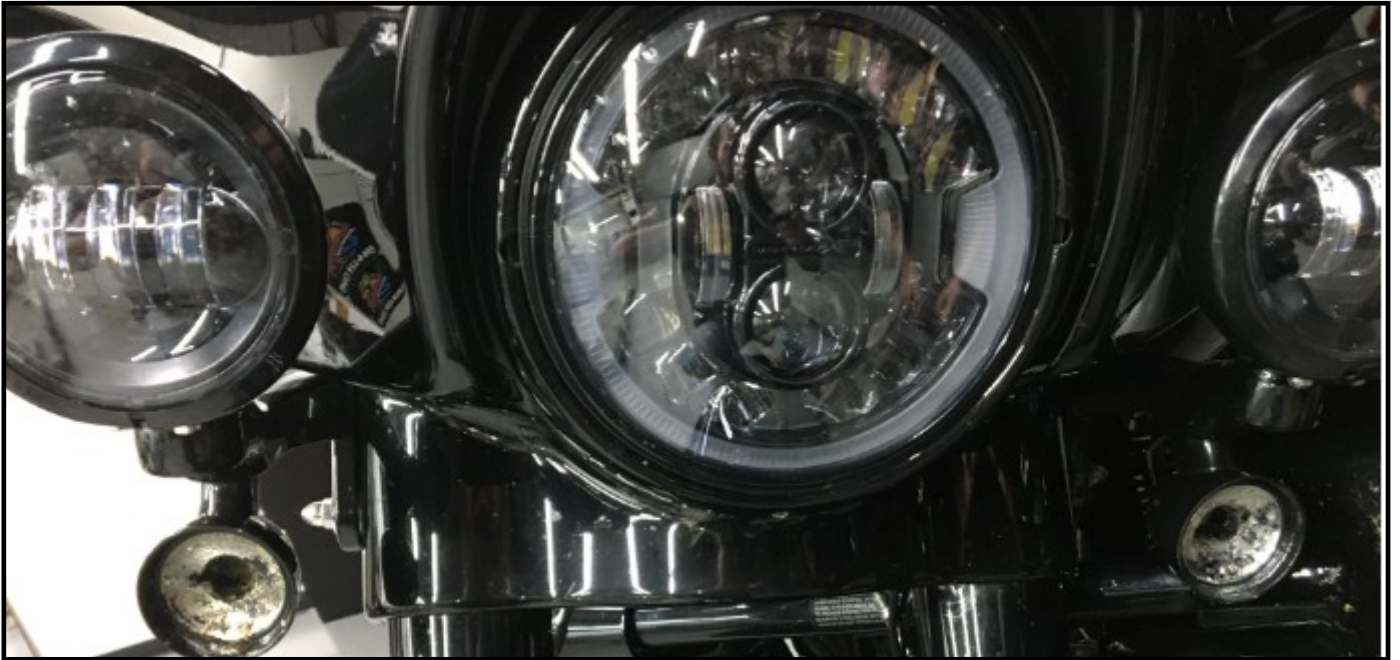
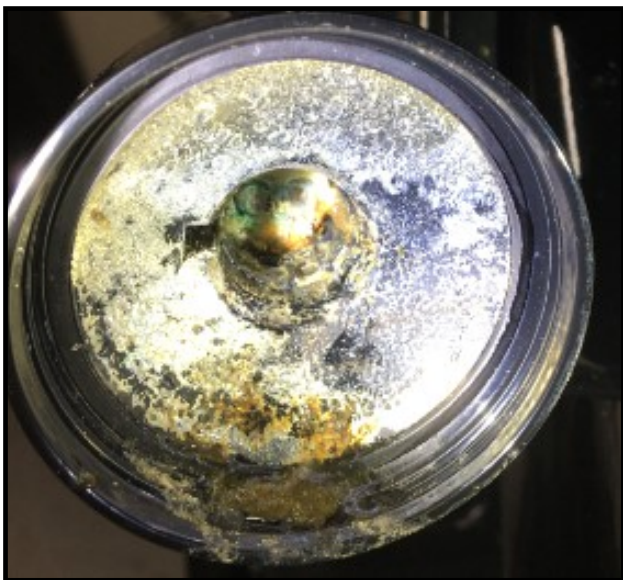
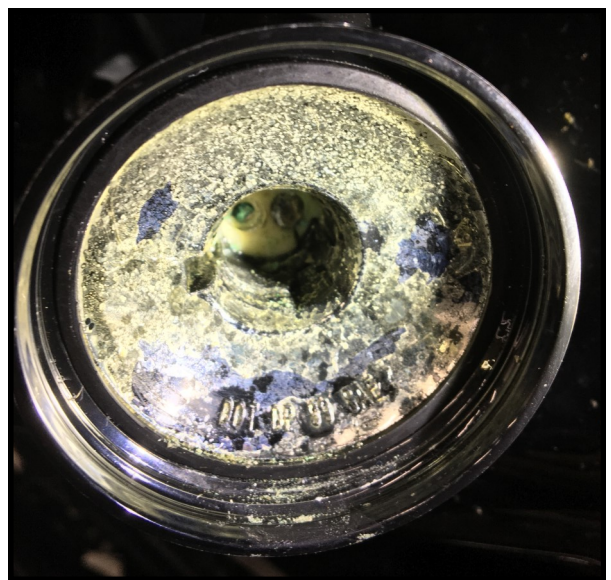
Here is an example of a bike and what happens if this issue is not addressed.
