CUSTOM DYNAMICS® | TECHNICAL SERVICE BULLETIN

# HEADLIGHT & TAILLIGHT CONDENSATION

How to identify normal lens condensation versus warrantable water ingress

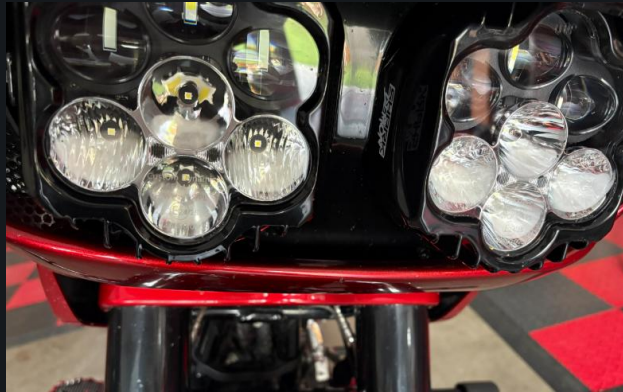
**ACCEPTABLE**

Condensation in cooler lens area

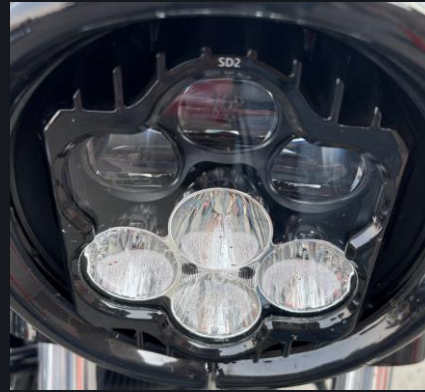
**ACCEPTABLE**

Small localized droplets near lens edge

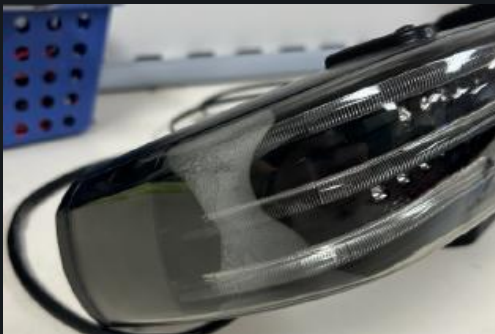
**ACCEPTABLE**

Light localized haze

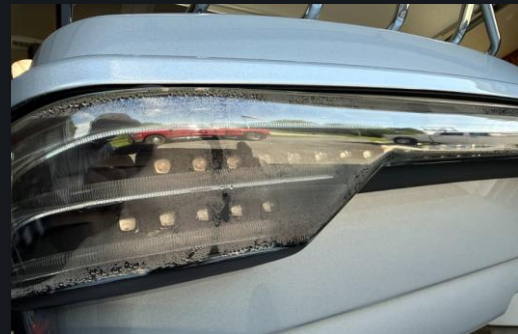
**ACCEPTABLE**

Fine misting / droplets; no standing water

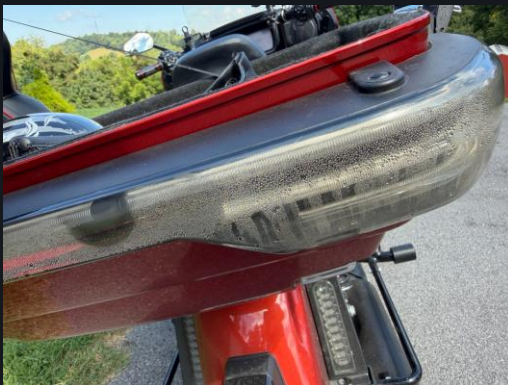
**WARRANTY REVIEW**

Heavy or widespread moisture

If heavy moisture remains after several normal operating cycles, repeatedly returns under normal conditions, forms running droplets, pools at the bottom of the housing, or affects lighting operation, contact Custom Dynamics for warranty evaluation.

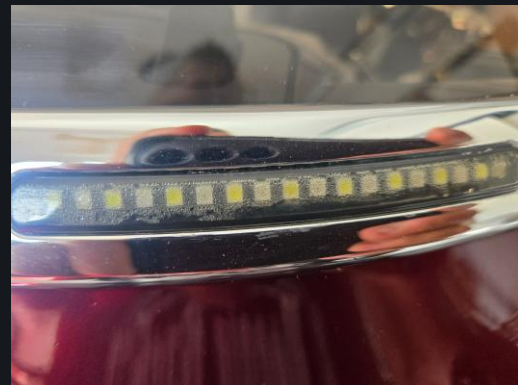
**WARRANTY REVIEW**

Persistent Droplets / Suspected Ingress
