CUSTOM DYNAMICS® | TECHNICAL SERVICE BULLETIN

# HEADLIGHT & TAILLIGHT CONDENSATION

How to identify normal lens condensation versus warrantable water ingress

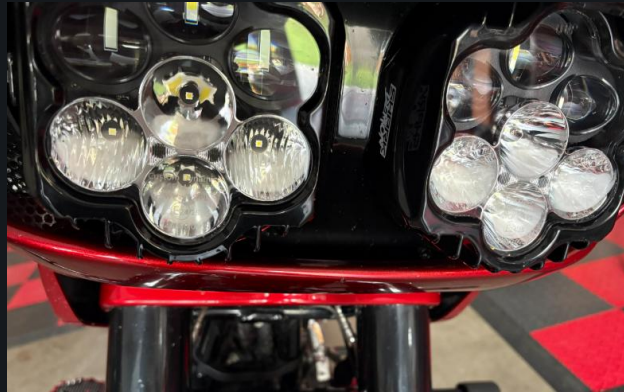
**ACCEPTABLE**

Condensation in cooler lens area

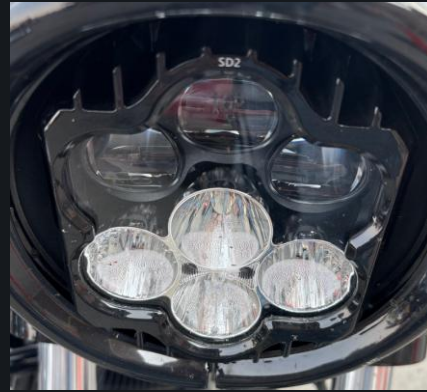
**ACCEPTABLE**

Small localized droplets near lens edge

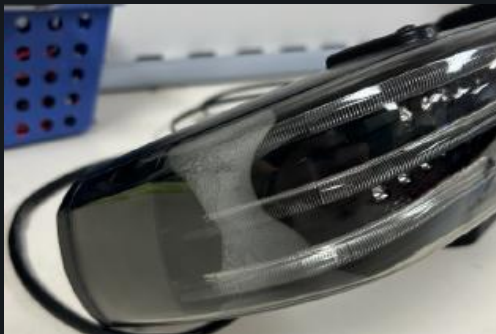
**ACCEPTABLE**

Light localized haze

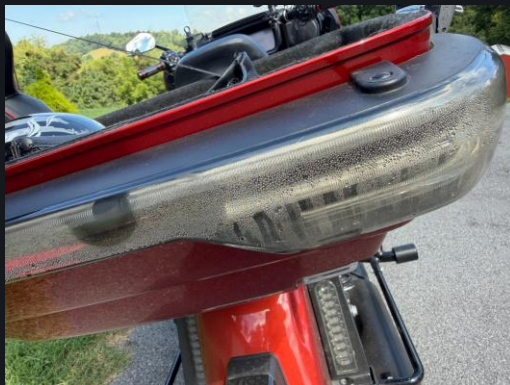
**WARRANTY REVIEW**

Heavy or widespread moisture

If heavy moisture remains after several normal operating cycles, repeatedly returns under normal conditions, forms running droplets, pools at the bottom of the housing, or affects lighting operation, contact Custom Dynamics for warranty evaluation.
